Analysis of Overheating On Auxiliary Engine Cat 18 On AHTS Ship Logindo Stamina

Marshelino Chandra Suhartono^{1*}, Aziz Nugroho¹, Trisnowati Rahayu¹, Antonius Edy Kristiyono¹, Monika Retno Gunarti¹, Shofa Dai Robbi¹, Imam Sutrisno²

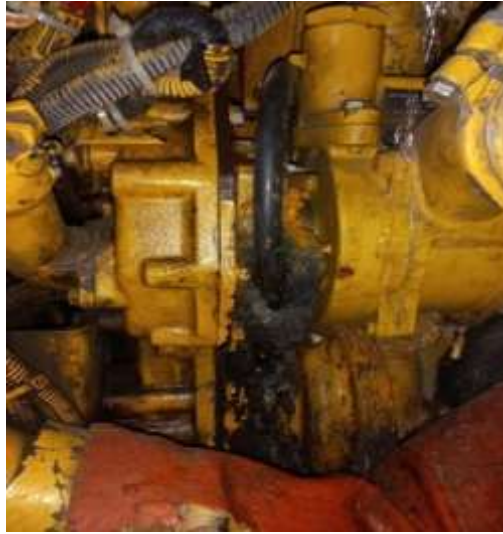
1. Cracked Sea Water Pump Cover

Figure 2 Cracked Sea Water Pump Cover
Source: Processed Research Data (2024)

Cracks in the seawater pump cover caused seawater seepage, which resulted in a decrease in pressure in the Open cooling system. This decrease in pressure caused the seawater circulation to be less than optimal so that the system's ability to absorb and remove heat from fresh water was disrupted. This was one of the initial triggers for the increase in coolant temperature above the normal operating limit of the engine (75–85°C), which was recorded at 93°C.

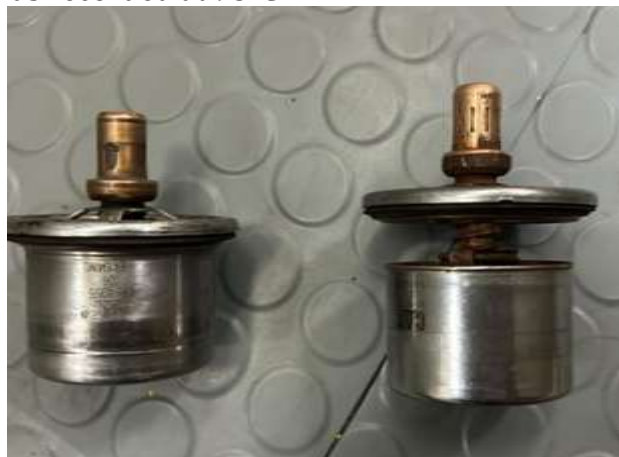
2. The damage *Thermostat*

Figure 3 *Thermostat*
Source: Research Document (2024)

Thermostat components experience malfunction due to long-term use and continuous exposure to high temperatures. A thermostat that is not working optimally cannot regulate the flow of coolant properly, which causes the fresh water temperature to increase drastically and the cooling system to become unstable. This study is in line with the findings [7] of thermostat damage, all of which contribute to overheating.

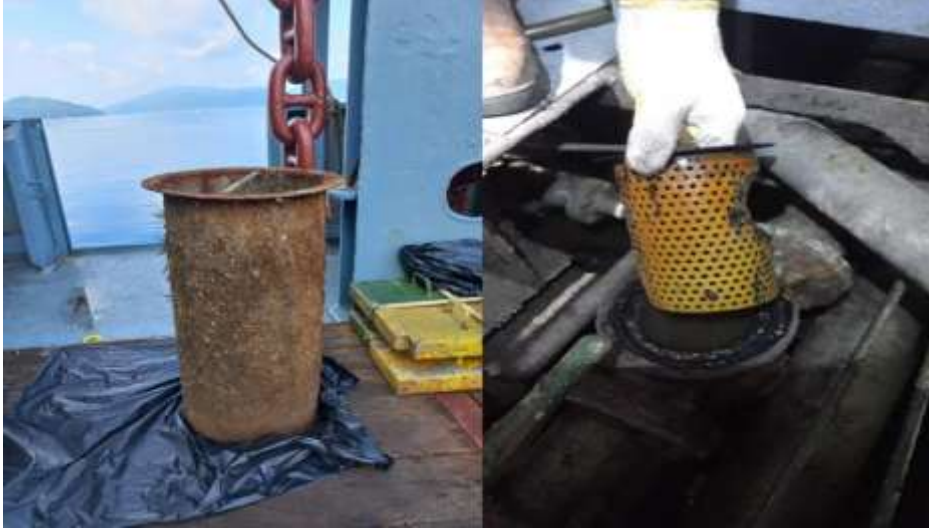
3. The blockage *Strainer Sea Chest*

Figure 4 *Strainer Sea Chest Dirty*
Source: Research Document (2024)

Dirt in the form of mud, shells, and organic marine waste was found to have accumulated in the sea chest strainer, which functions to filter seawater before it enters the cooling system. As a result, the flow of seawater is hampered and the cooling process for fresh water becomes inefficient. This is exacerbated by the lack of routine cleaning activities as regulated in the Plan Maintenance System (PMS).

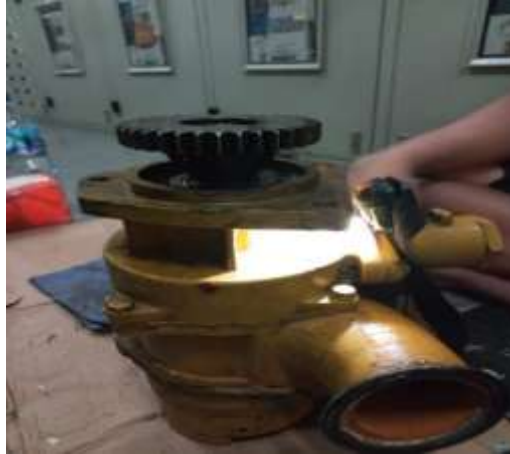
Figure 5 Patched Seawater Cooling Pump Cover

The crack found on the seawater pump cover is one of the root causes of the cooling system disruption. This crack causes a leak in the seawater flow, which results in a decrease in pressure in the secondary cooling water circulation. This unstable pressure has a direct impact on the inefficiency of the heat exchange process between seawater and fresh water through the heat exchanger. As a result, the system's capacity to stabilize the engine temperature is disrupted, and the fresh water temperature increases significantly, reaching a critical temperature of 93°C. This incident proves that mechanical components such as pumps have a crucial role in maintaining the integrity of the ship's cooling system. This is in accordance with [25], which states that cracks in the seawater pump cover are one of the main factors causing disruption to the cooling system. This crack causes a decrease in pressure and flow of seawater which should function as a cooling medium, so that cooling efficiency

1. Patching of cracks in sea water pump covers using Devcon A10110, a metal epoxy adhesive that is resistant to high temperatures and marine environments. Cracks in the seawater pump cover caused a decrease in circulation pressure, disrupting the efficiency of heat exchange in the heat exchanger. To address this, Devcon A10110, a type of high temperature and corrosion resistant metal epoxy, was used. This method is in line with recommendations [14] which emphasize the importance of rapid repair using marine-resistant materials. The application process includes cleaning the area, drying, and applying the epoxy material according to the technical guidelines. This approach has proven effective in restoring the pressure of the cooling system without having to replace the entire pump unit, reducing operational downtime.

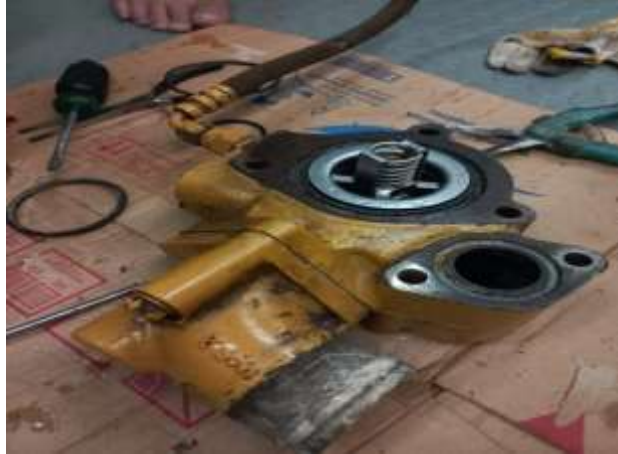
Figure 6 Substitution *Thermostat*

The thermostat that was no longer functioning properly was found to be unable to regulate the flow of coolant optimally. The damage occurred due to long service life and continuous exposure to high temperatures. For this reason, the thermostat was replaced with a new unit according to the specifications of the Caterpillar C-18 engine. The replacement process was carried out carefully so as not to damage the housing and water lines. After the installation was complete, a test was carried out on the engine's operating temperature to ensure that the system was working normally. This action reinforces the importance of regular inspection of the temperature control components, as explained by [7] Thermostats that have exceeded their service life show physical and functional damage, which causes the failure of fresh water temperature regulation in a closed cooling system. A damaged thermostat cannot open and close properly according to temperature changes, so that fresh water is unable to circulate optimally through the heat exchanger. This causes an increase in the internal temperature of the engine, accelerates the wear process of other components, and leads to operational disturbances such as the engine "ngejam" or stalling. This condition highlights the importance of component life management and routine inspection of the temperature control system. This is supported by [26] explaining that components such as thermostats that have exceeded their service life are susceptible to damage both physically and functionally. This damage causes the thermostat to fail to regulate the flow of fresh water in a closed cooling system, so that the engine temperature cannot be maintained

2. Replacing the thermostat with an original spare unit that meets engine specifications *Caterpillar C-18*.

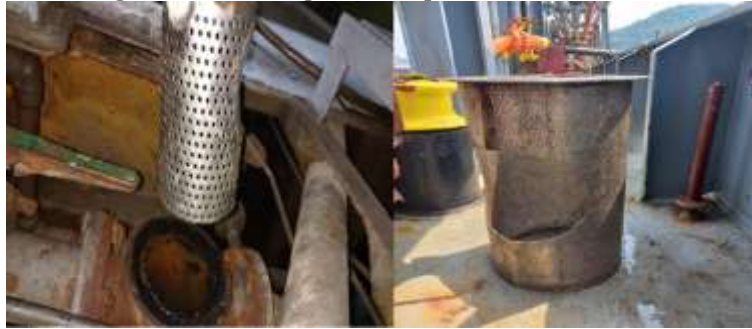
3. Strainer Blockage on Sea Chest

Figure 7 Strainer sea chest pump strainer sea water CAT 18 diesel engine
Source: Research Document (2024)

logging of the sea chest strainer due to the accumulation of mud, sea shells, and organic waste is a very common but often overlooked factor. The strainer functions as an initial filter for sea water entering the cooling system, and if it is clogged, the sea water discharge is drastically reduced, so that the system does not get enough coolant to absorb heat from the fresh water. This blockage generally occurs because periodic cleaning is not carried out according to the Plan Maintenance System (PMS) standards. This finding underlines the importance of monitoring the cleanliness of the sea water inlet, especially when the ship is docked at a port with low water quality. This is in line with [27] which emphasizes that clogging of the sea chest strainer due to the accumulation of mud, sea shells, and organic waste is a common problem that often occurs in the operational environment of ships.

Re-implementation of Plan Maintenance System (PMS) consistently for periodic inspection and cleaning of strainers, sea chests, and all cooling system components. The thermostat that was no longer functioning properly was found to be unable to regulate the flow of coolant optimally. The damage occurred due to long service life and continuous exposure to high temperatures. For this reason, the thermostat was replaced with a new unit according to the specifications of the Caterpillar C-18 engine. The replacement process was carried out carefully so as not to damage the housing and water lines. After the installation was complete, a test was carried out on the engine's operating temperature to ensure that the system was working normally. This action reinforces the importance of regular inspection of the temperature control components, as explained by [7]. After the implementation of these actions, the engine operating temperature returned to the normal operating range (78–82°C), indicating that the cooling system had returned to optimal functioning. These steps have proven effective in lowering the engine operating temperature to the normal range.
